# CASE STUDY TECHNICAL SHEET

## Case study 2 – Residential single-family home, Kelowna,

**British Columbia** (This case study should be read with Case study 3 – Residential single-family home, Kelowna, British Columbia, South side system (Cat. No. M91-19/3-2021E-PDF, ISBN 978-0-660-40850-7).

### NORTH SIDE SYSTEM

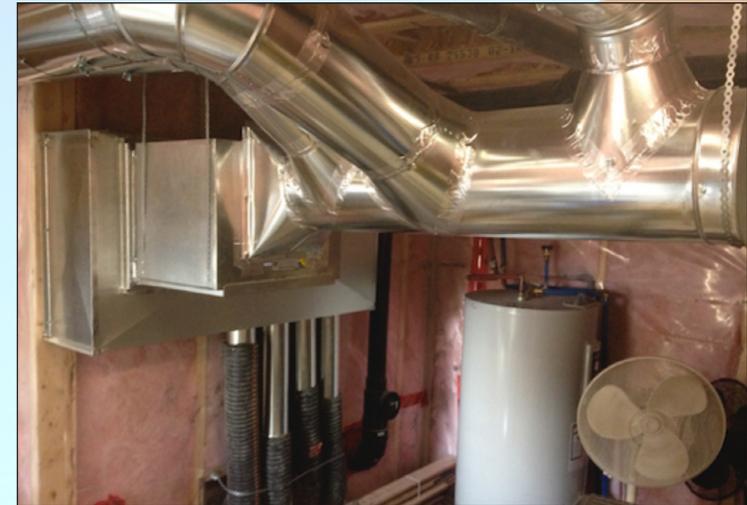
**Figure 1. The layout of tubes connected to a supply fan and ducting.**

The ventilation system is an in-line fan that is connected directly to the bedroom and the living room. The outside air (OA) inlet is located on the north side of the building, which is mostly in the shade. See Figure 1.

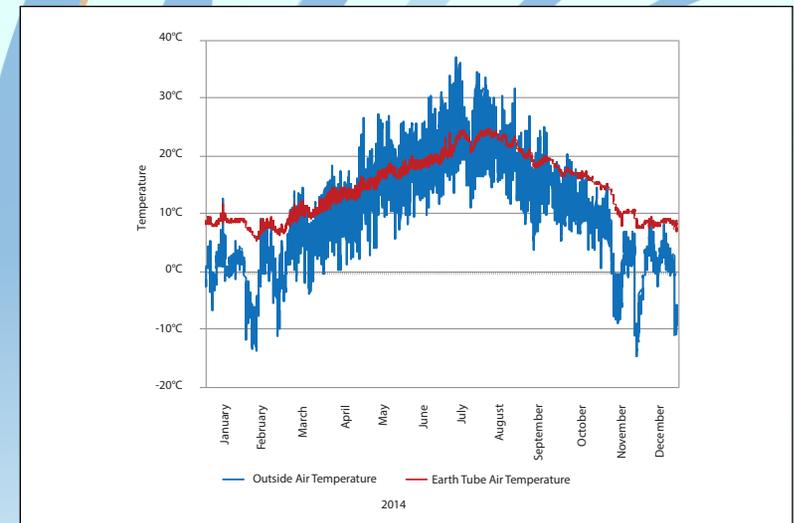
**Figure 2. Energy performance of the system, 2014.**

The earth tube system was monitored, and earth tube air temperature (ETAT) and outdoor air temperature (OAT) data were recorded in 2014. See Figure 2.

The earth tube system was monitored for more a year, starting in 2014. The results indicate a well-performing system.

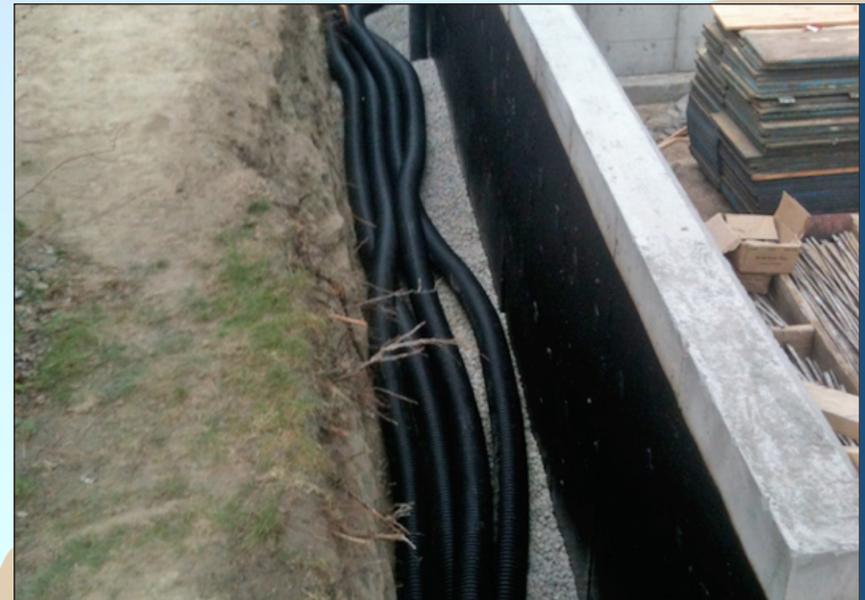
**Figure 3. Pipes in a trench before it is backfilled**

The system is a single pass supply of outdoor air for passive cooling, provided by four 23-m lengths of 100-mm diameter pipe. The four pipes run parallel in a common trench, each with two 90-degree bends.

The pipes are covered with 1.6 m of soil in a gently sloped hillside, facing south-southeast. See figures 3 and 4.

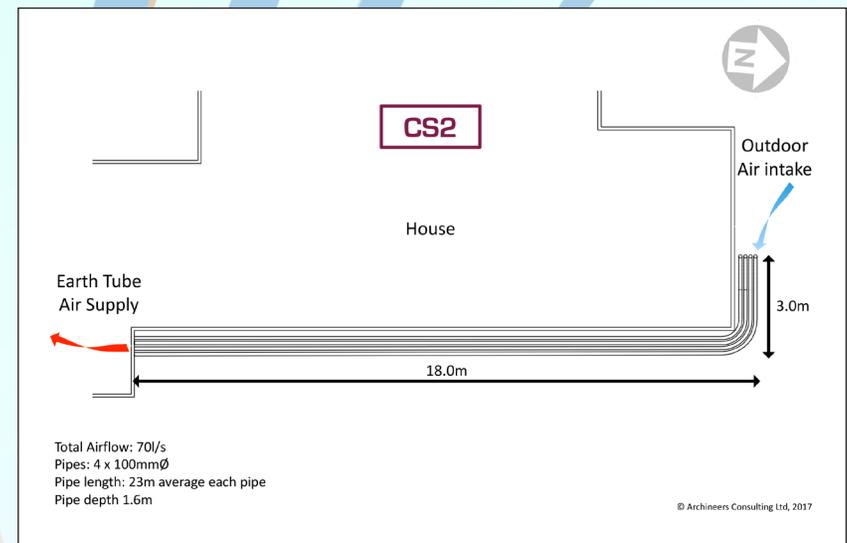
**Figure 4. Pipe layout**
